Chapter 2: Historical Perspective

Historical Perspective

This chapter describes coastal flood and wind events that have affected the continental United States, Alaska, Hawaii, and U.S. Territories since the beginning of this century. Findings of post-event building performance and damage assessments are summarized, as are the lessons learned regarding factors that contribute to flood and wind damage.

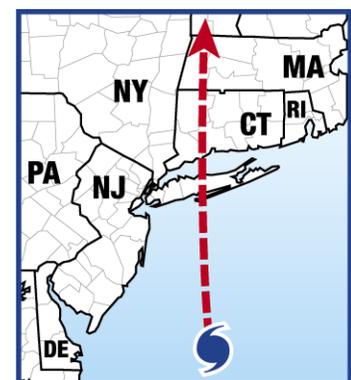
Figure 2-1

1938 Hurricane. Schell Beach, Guilford, Connecticut, before and after the storm. Unelevated houses at the shoreline were destroyed. WPA photograph, from Minsinger (1988).

1938, September 21 – New England Hurricane. The 1938 hurricane was one of the strongest ever to strike New York and New England. Although the maximum sustained wind speed at the storm's peak was estimated at 140 mph, by landfall the wind speeds had diminished substantially (NOAA 1996). The storm, like most other hurricanes striking the area (e.g., Hurricane Gloria in 1985), had a forward speed in excess of 30 mph at the time of landfall, and it moved through the area rapidly. Despite its high forward speed, the storm caused widespread and significant damage to buildings close to the shoreline (see Figure 2-1) (surge and wave damage) and to buildings away from the coast (wind and tree-fall damage). Minsinger (1988) provides documentation of the storm and the damage it caused, which, according to NOAA (1997), rank this storm as the eighth most costly hurricane to strike the United States this century.

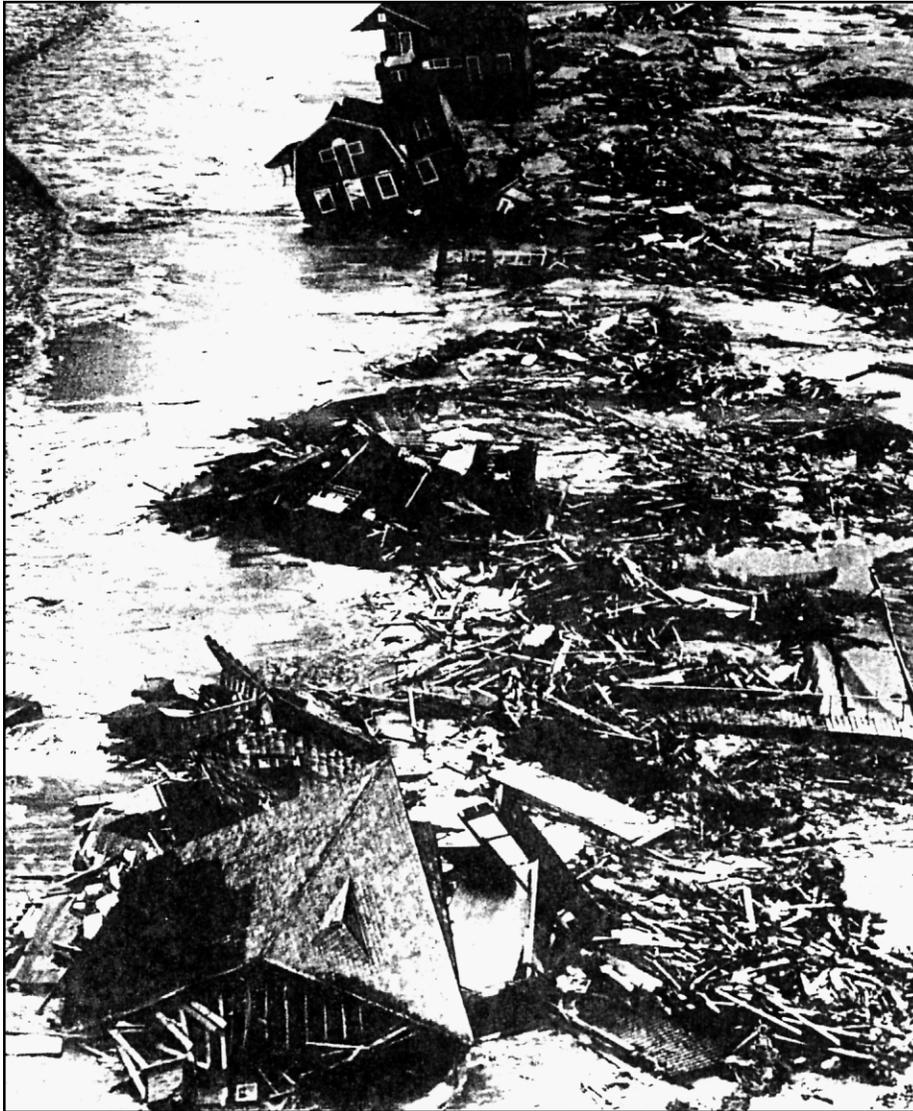
Figure 2-2
1962 Mid-Atlantic storm.
Extreme damage to homes
along the beach at Point-o-
Woods, Fire Island, New York.
UPI/Corbis-Bettmann
photograph.

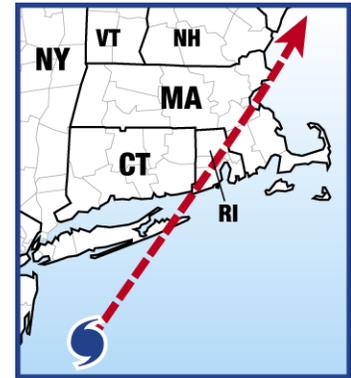
Figure 2-4
October 1991 northeaster
damage to homes at
Scituate, Massachusetts.
Photograph by Jim O'Connell.

- Buildings atop continuous masonry block foundations (such as those permitted in A zones) commonly were damaged or destroyed when exposed to flooding, wave action, erosion, and/or localized scour (see Figure 2-4).

- Buildings atop continuous cast-in-place concrete foundations performed better than those atop continuous masonry block foundations, and were generally more resistant to wave and flood damage; however, some continuous cast-in-place concrete foundations were damaged as a result of the footing being undermined by erosion and localized scour.

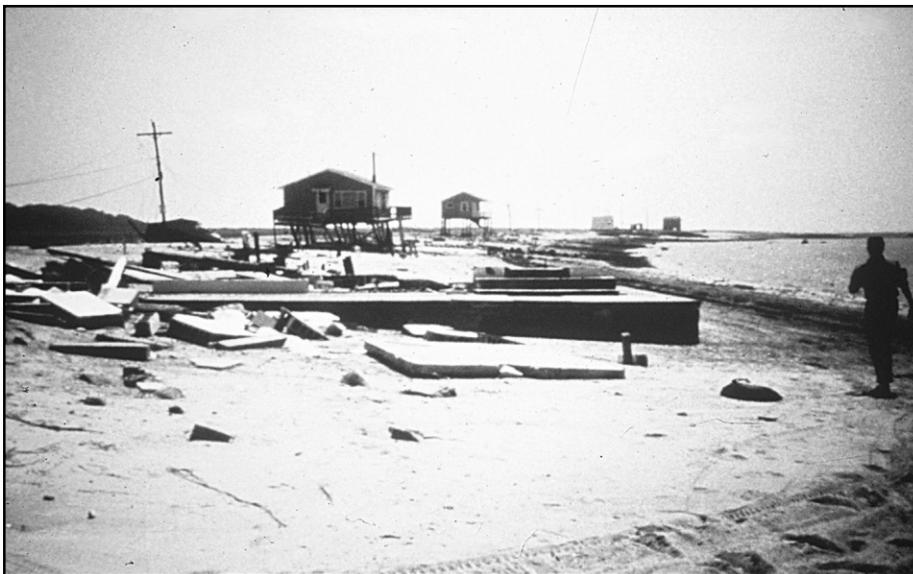
Figure 2-3
Hurricane Bob (1991)
destroyed 29 homes along
this reach of Mattapoisett,
Massachusetts. Photograph
by Jim O'Connell.

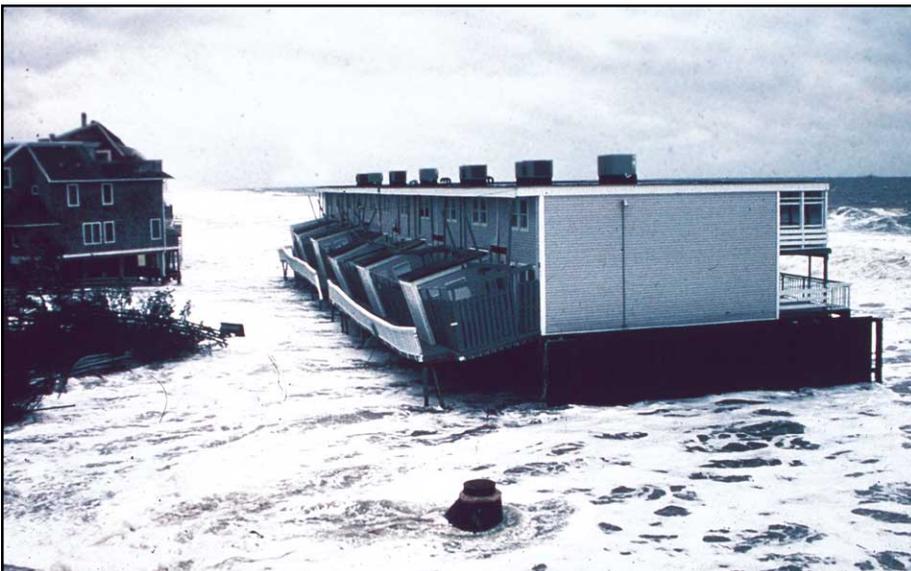
Figure 2-5
1992 storm impacts at
Dewey Beach, Delaware.
Note collapse of deck on
landward side of building.
Photograph by Anthony Pratt.

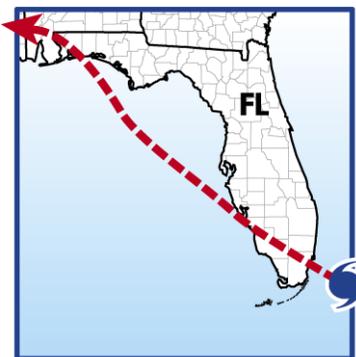
Figure 2-6
Building damage from 1926
hurricane, Miami, Florida.

Buildings under three stories in height – “... the most pertinent conclusion that may be reached is that the fault lies in the actual construction in the field, such as lack of attention to small detail, anchors, ties, bracing, reinforcing, carpentry, and masonry work.”

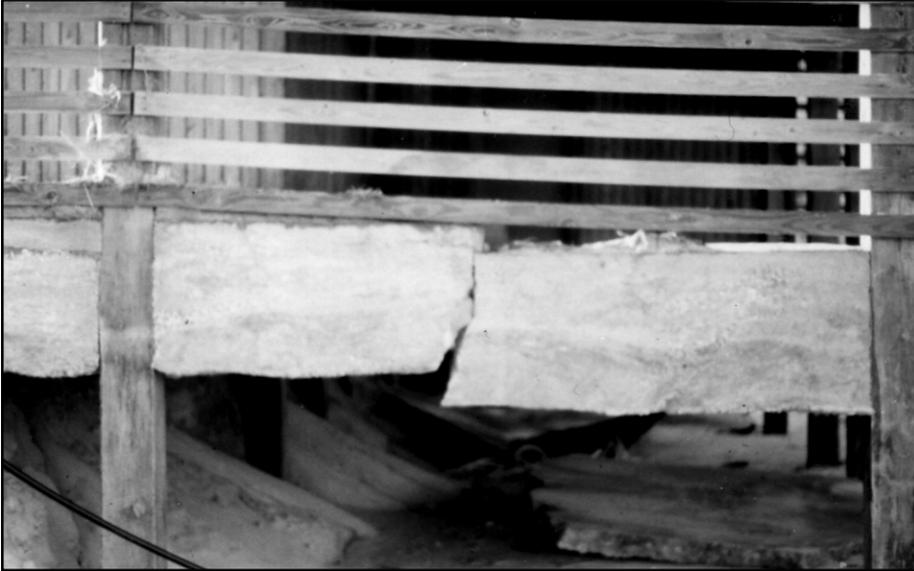
- Once undermined, plain concrete slabs, and grade beams cast monolithically with them, failed under their own weight or as a result of wave and debris loads (see Figure 2-7).

Figure 2-7
March 1989 northeaster. This plain concrete perimeter grade beam cracked in several places.

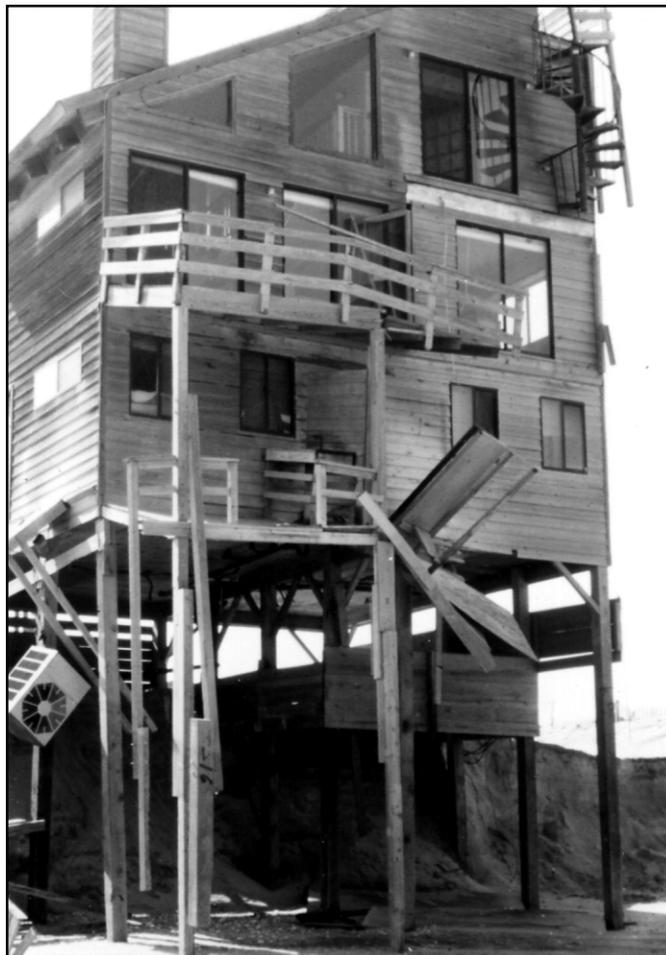
Figure 2-8
March 1989 northeaster. Although this house seems to have lost only several decks and a porch, the loss of supporting soil leaves its structural integrity in question.

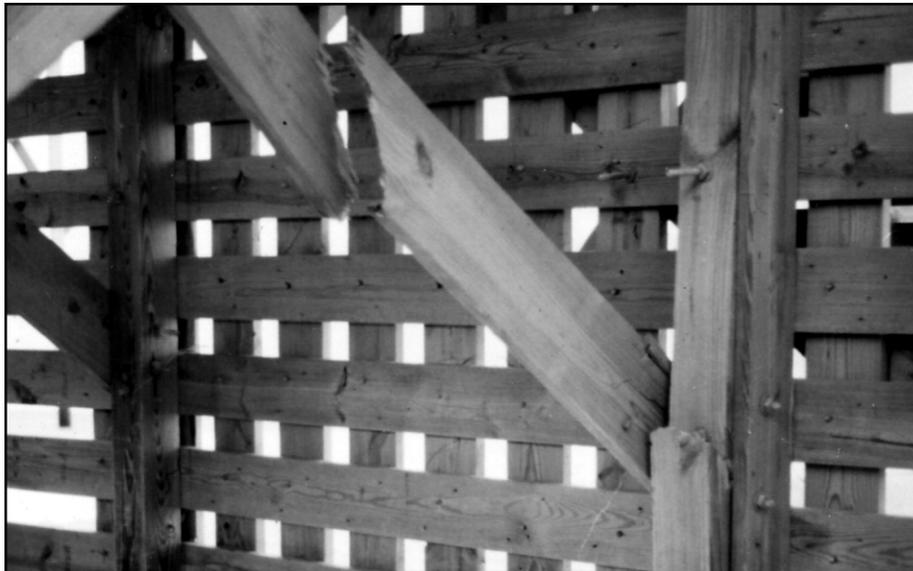
- Many of the buildings affected during the April 1988 storm were further damaged during the March 1989 storm, because of either additional erosion and undermining or debris damage to cross-bracing and foundation piles (see Figures 2-9 and 2-10).

Figure 2-10
March 1989 northeaster.
Deck pile broken by debris
impact. Flood forces also
caused piles to crack at
overnotched connections to
floor beam.

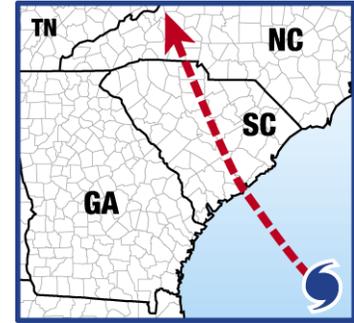
Figure 2-11
Hurricane Hugo (1989),
Garden City Beach, South
Carolina. House on pilings
survived while others did
not.

- Post-FIRM buildings that were both properly constructed and elevated survived the storm (see Figure 2-11). These buildings stood out in sharp contrast to pre-FIRM buildings and to post-FIRM buildings that were poorly designed or constructed.

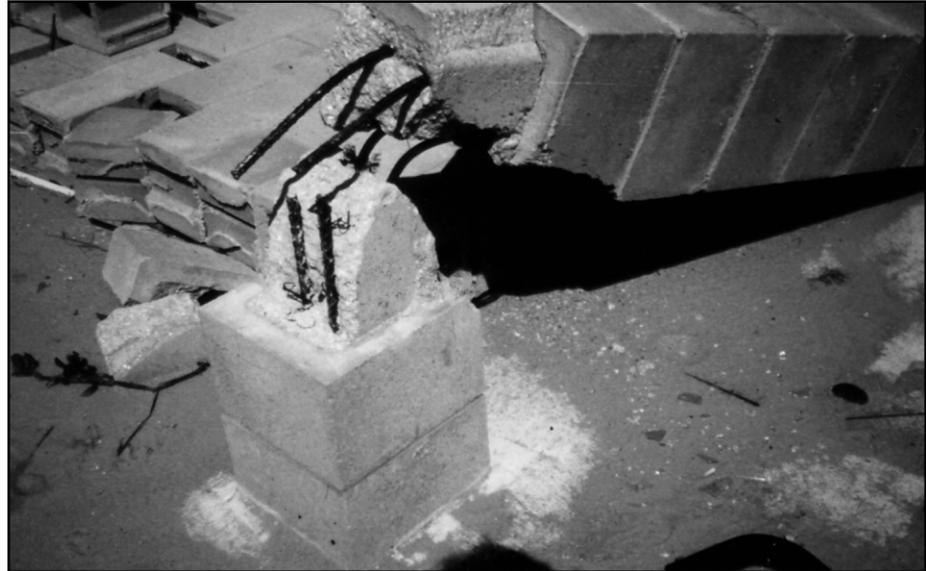
- Many buildings elevated on masonry or reinforced concrete columns supported by shallow footings failed. In some instances, the columns were undermined; in others, the columns failed as a result of poor construction (see Figure 2-12).
- Several pile-supported buildings not elevated entirely above the wave crest showed damage or destruction of floor beams, floor joists, floors, and exterior walls.
- Some of the most severely damaged buildings were in the second, third, and fourth rows back from the shoreline. These areas were mapped as A zones on the FIRMs for the affected communities. Consideration should be given to more stringent design standards for coastal A zones.

Figure 2-12
Hurricane Hugo (1989), South Carolina. Failure of reinforced masonry column.

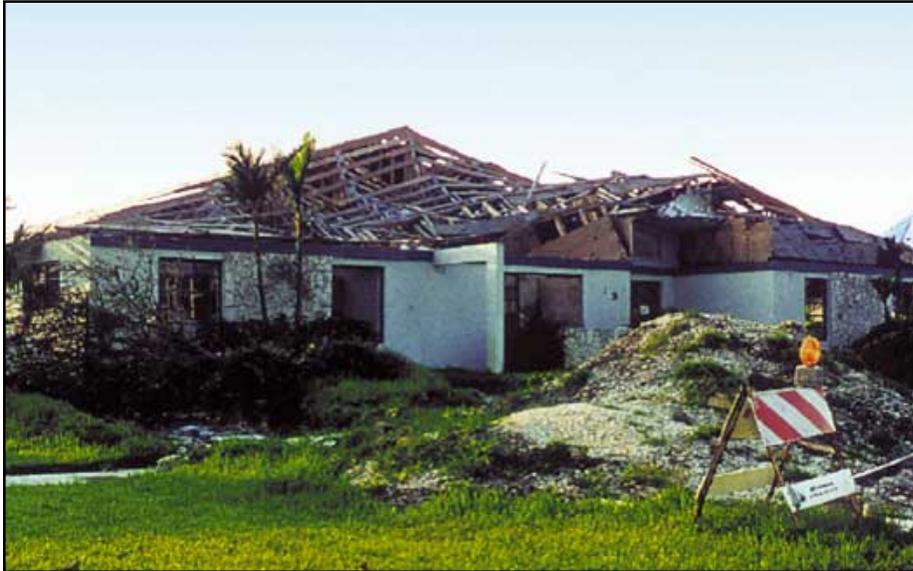
- c) inadequate roof truss bracing or bridging (see Figure 2-13)
- d) improper sillplate-to-foundation or sillplate-to-masonry connections

Figure 2-13
Hurricane Andrew (1992).
Roof structure failure due to
inadequate bracing.

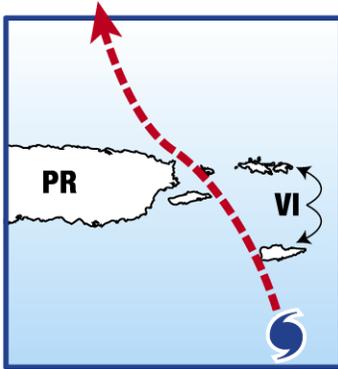
Figure 2-14
Hurricane Marilyn (1995). This house lost most of the metal roof covering. Neighbors stated that the house also lost its roof covering during Hurricane Hugo, in 1989.

As documented by the National Roofing Contractors Association (NRCA 1996), most of the wind damage consisted of either the loss of roof sections (see Figure 2-14)—usually metal decking installed on purlins attached to roof beams spaced up to 48 inches on center—or failures of gable ends. In addition, airborne debris penetrated roofs (see Figure 2-15) and unprotected door and window openings. This damage allowed wind to enter buildings and cause structural failures in roofs and under-reinforced walls. Near the tops of high bluffs, wind speedup effects resulted in damage that better represented 140-mph sustained winds.

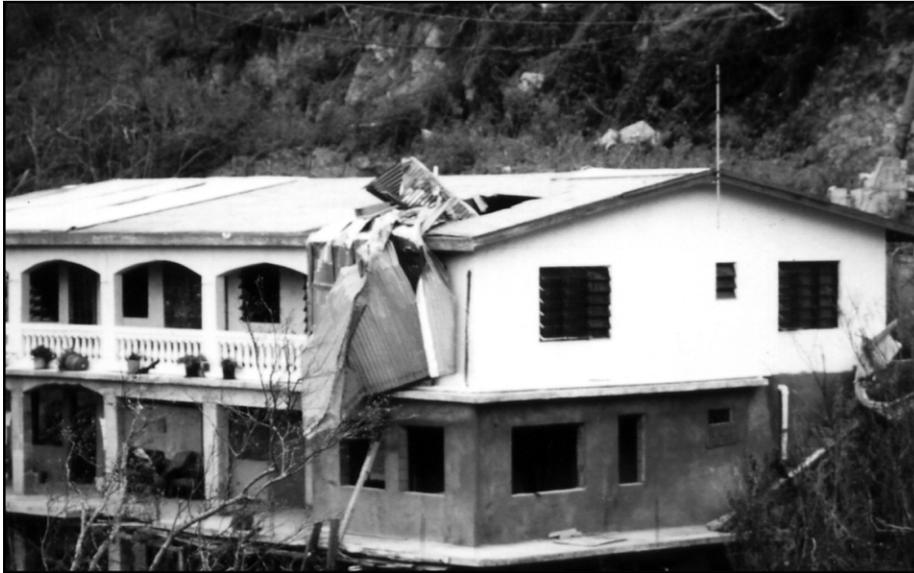
Figure 2-15
Hurricane Marilyn (1995).
The roof of this house was
penetrated by a large wind-
driven missile (metal roof
covering).

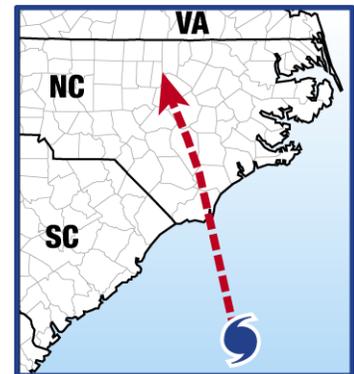
Figure 2-16
Hurricane Fran (1996). Many oceanfront houses built before the enactment of the 1986 North Carolina State Code were found to be leaning or destroyed.

- Hundreds of oceanfront houses were destroyed by the storm, mostly as a result of insufficient pile embedment (see Figure 2-16) and wave effects. Most of the destroyed buildings had been constructed under an older building code provision that required that piling foundations extend only 8 feet below the original ground elevation. Erosion around the destroyed oceanfront foundations was typically 5–8 feet. In contrast, foundation failures were rare in similar, piling-supported buildings located farther from the ocean and not subject to erosion.

- A significant reduction in building losses was observed in similarly sized oceanfront buildings constructed after the North Carolina Building Code was amended in 1986 to require a minimum embedment to –5.0 feet National Geodetic Vertical Datum (NGVD) or 16 feet below the original ground elevation, whichever is shallower, for

pilings near the ocean. A study of Topsail Island found that 98 percent of post-1986 oceanfront houses (200 of 205) remained after the hurricane. Ninety-two percent of the total displayed no significant damage to the integrity of the piling foundation. However, 5 percent (11) were found to have leaning foundations (see Figure 2-16). A non-destructive test used to measure piling length in a partial sample of the leaning buildings revealed that none of the leaning pilings tested met the required piling embedment standard. Many were much shorter. However, given the uncertainty of predicting future erosion, the BPAT recommended that consideration be given to a piling embedment standard of -10.0 feet NGVD.

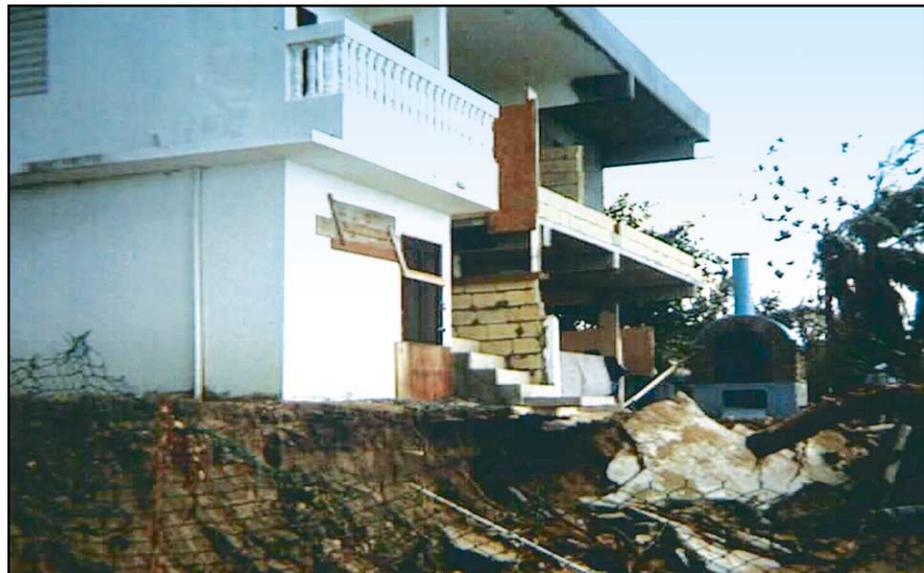
Figure 2-17
Hurricane Georges (1998).
Coastal building in Puerto Rico damaged by storm surge and waves.

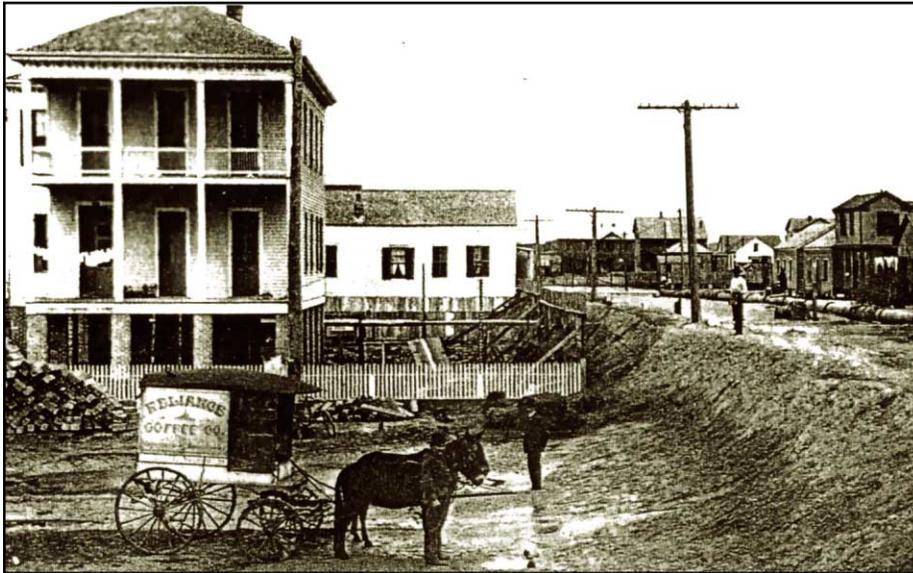
Figure 2-18

Galveston on two levels—the area at the right has already been raised; on the left, houses have been lifted, but the land is still low. Photograph courtesy of the Rosenberg Library, Galveston, Texas.

1900, September 8 – Galveston, Texas. This Category 4 hurricane was responsible for over 8,000 deaths—it is the most deadly natural disaster to affect the United States. The storm caused widespread destruction of much of the development on Galveston Island and pointed out the benefits of siting construction away from the shoreline. As a result, the city completed the first, large-scale retrofitting project (see Figure 2-18): roads and hundreds of buildings were elevated, ground levels in the city were raised several feet with sand fill, and the Galveston seawall was built (Walden 1990).

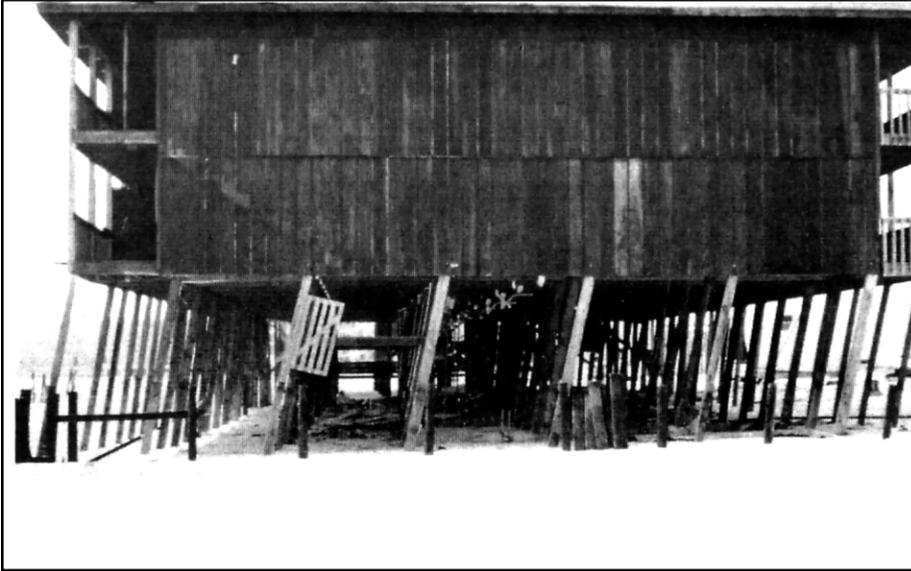
Figure 2-19
Hurricane Frederic (1979).
Effects of wind and water
forces on unbraced pile
foundation.

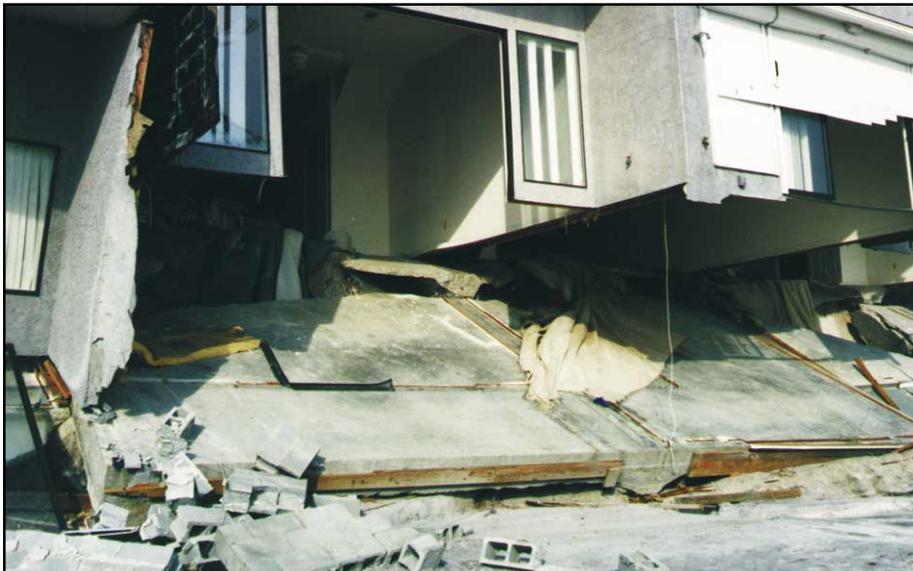
Figure 2-20
Hurricane Opal (1995), Bay
County, Florida. Building
damage from erosion and
undermining.

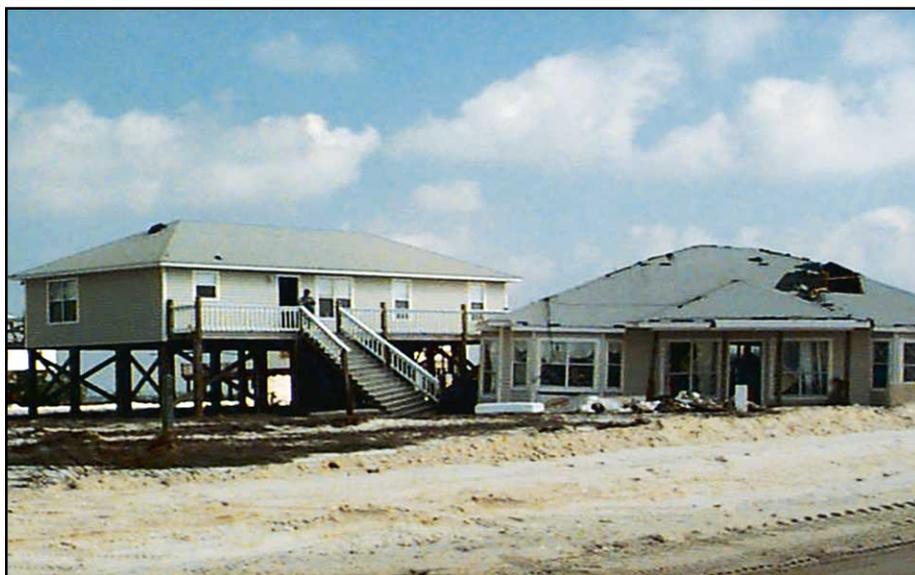
Figure 2-21
Hurricane Georges (1998),
Dauphin Island, Alabama. As
a result of erosion, scour, and
inadequate pile embedment,
the house on the right was
washed off its foundation
and into the house on the
left.

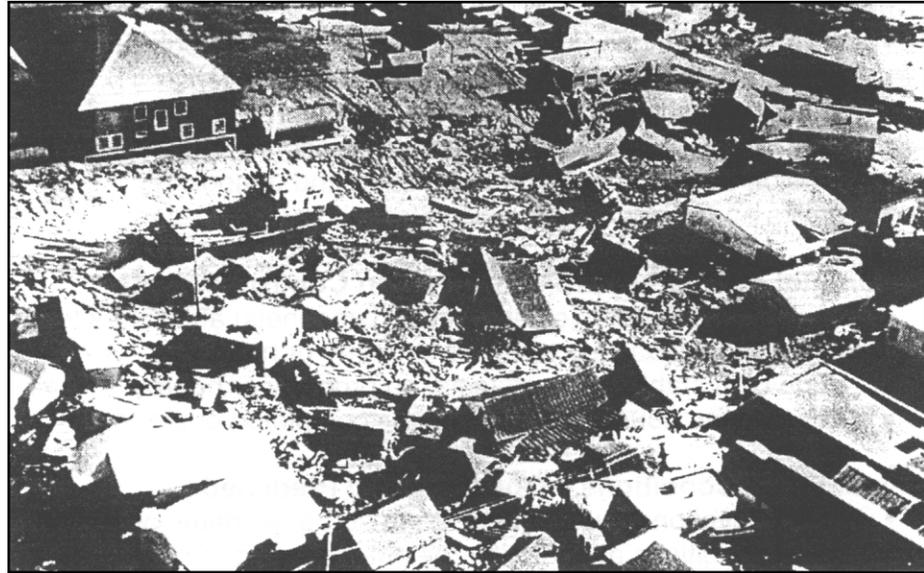
Figure 2-22
1964 Good Friday earthquake. Damage in Kodiak City, Alaska, caused by the tsunami of the 1964 Alaskan earthquake (from Wilson and Tørum 1968).

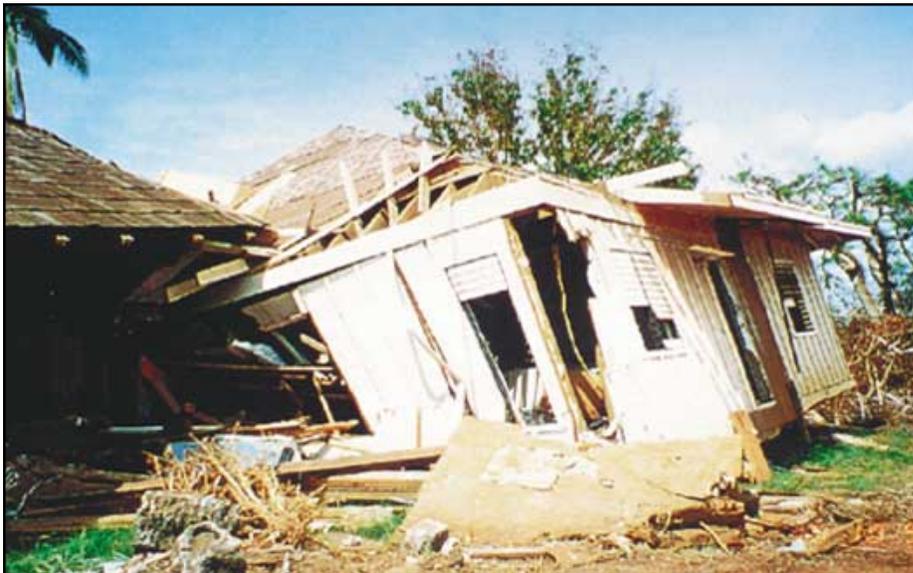
Figure 2-24
Hurricane Iniki (1992).
Non-elevated house at Poipu Beach that floated off its foundation and was pinned against another house and destroyed by waves.

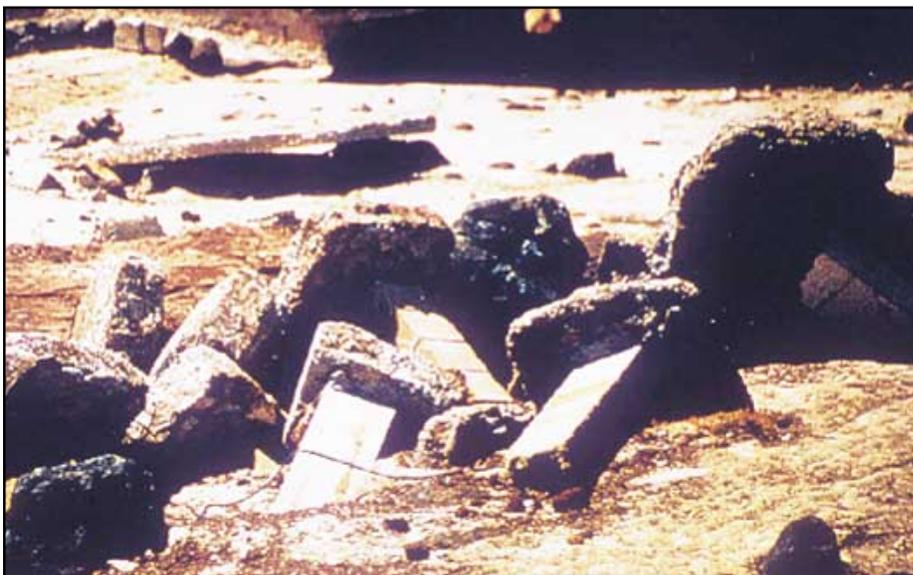
Figure 2-25
Hurricane Iniki (1992).
Undermining of shallow footings supporting columns at Poipu Beach due to lack of sufficient embedment below erosion level.

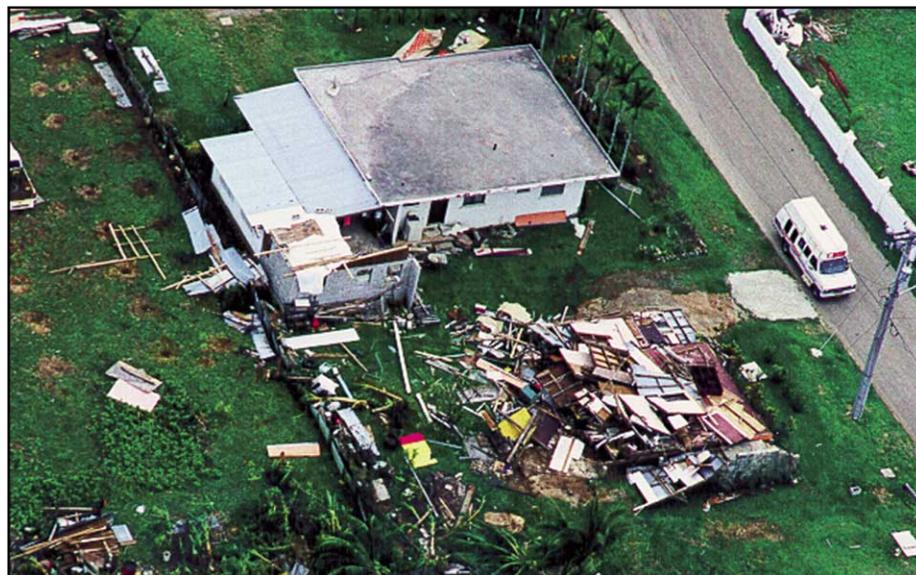
Figure 2-26

Typhoon Paka (1997). Although damaged by the storm, the concrete house in the upper part of the photograph survived, while the wood-frame house next to it was destroyed.

1997, December 16 – Typhoon Paka, Guam. In January 1998, FEMA deployed a Hazard Mitigation Technical Assistance Program (HMTAP) team to Guam to evaluate building performance and damage to electric power distribution systems. In its report (FEMA 1998), the team noted that damage to wood-frame buildings was substantial, but that many buildings were built with reinforced masonry or reinforced concrete and survived the storm with minimal damage (see Figure 2-26). Many of the roof systems were flat and many were covered with a “painted-on” coating that also survived the storm with almost no damage. At the time of the storm, Guam used the 1994 Uniform Building Code (ICBO 1994) but has adopted a local amendment specifying a design wind speed of 155 mph (fastest-mile basis).

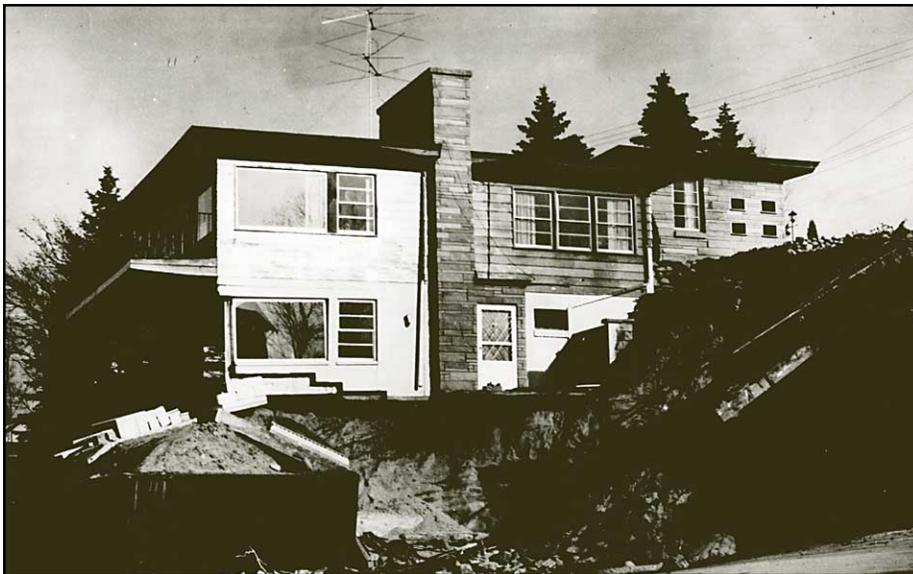
Figure 2-27
House on southeastern shoreline of Lake Michigan undermined by erosion during storm of November 1951. Photograph courtesy of USACE, Chicago District.

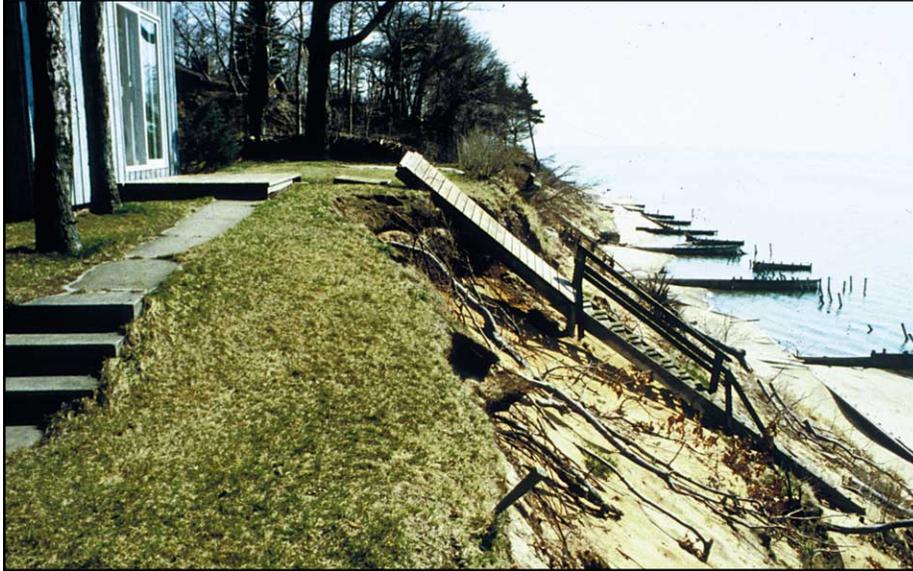
Figure 2-28
August 1988. Erosion along the Lake Michigan shoreline at Holland, Michigan, resulting from high lake levels and storm activity (photo courtesy of Mark Crowell).
