Chapter 14:

Maintaining the Building

14.1 Introduction

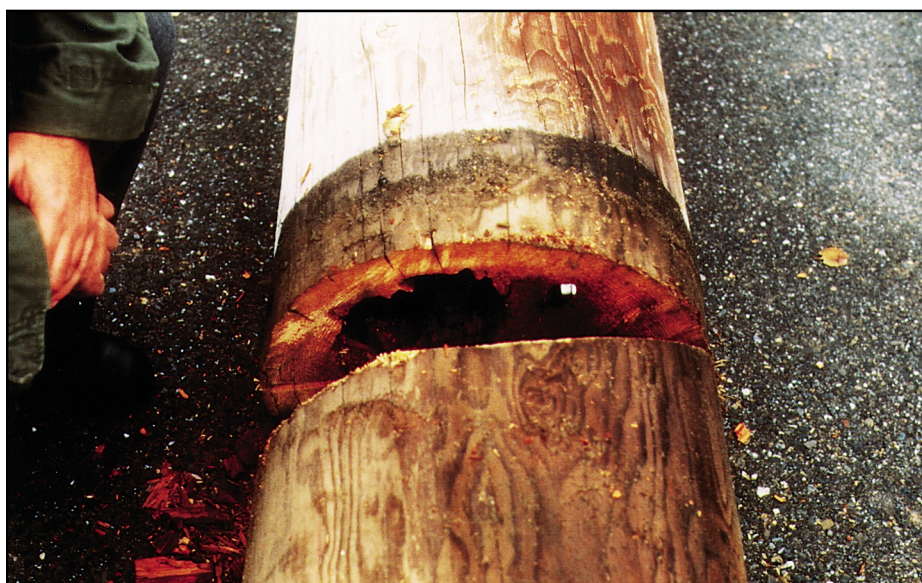
Figure 14-1
Pile that appears acceptable from the outside but that is decayed in the center.

To maintain maximum building performance, a coastal building's structural system and envelope (i.e., exterior wall covering, doors, windows, and roof covering) must not be allowed to deteriorate. If the building is significantly degraded by corrosion, wood decay, termite attack, or weathering, its vulnerability to damage from natural hazards is increased. Figure 14-1 shows a decayed pile that appears from the outside to be in acceptable condition. Under the loads imposed by a natural hazard event, this pile could fail.

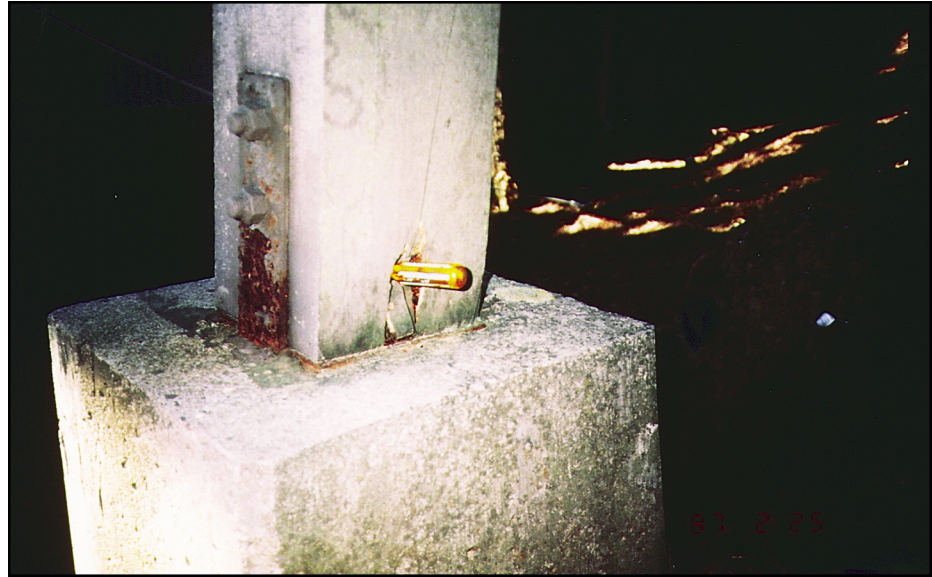
Wood decay at the base of a post supported by concrete.

There are many sources of exterior moisture in the coastal environment. Wherever this moisture is retained, wood decay, mildew, or other forms of deterioration can progress. For example, Figure 14-2 shows decay at the base of a wood post where moisture was retained, and Figure 14-3 shows decay behind a connection plate for a beam. Interior moisture must also be considered. Significant interior sources of water vapor, such as kitchens, baths, and clothes dryers, should be vented to the outside in such a way that condensation does not occur on interior or exterior surfaces.

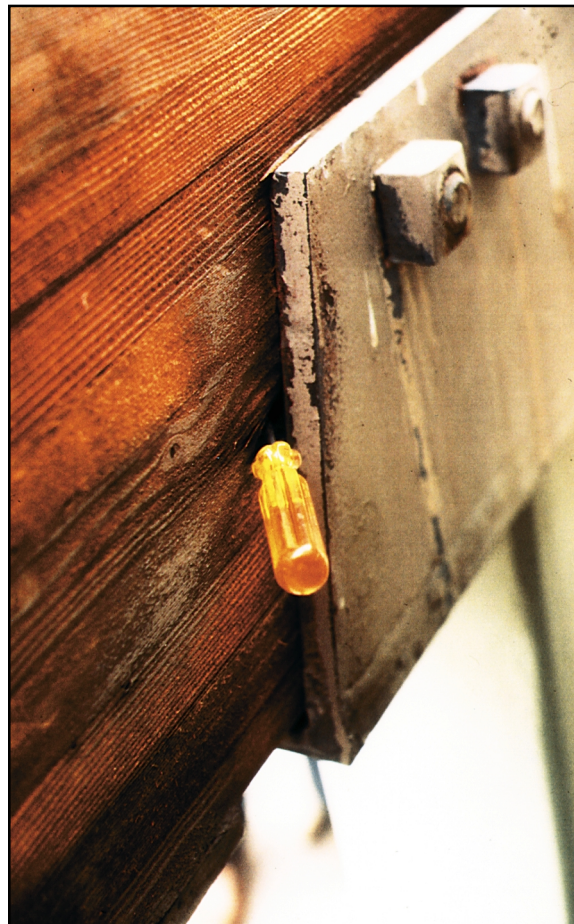
**Figure 14-3**

Wood decay behind a metal beam connector.

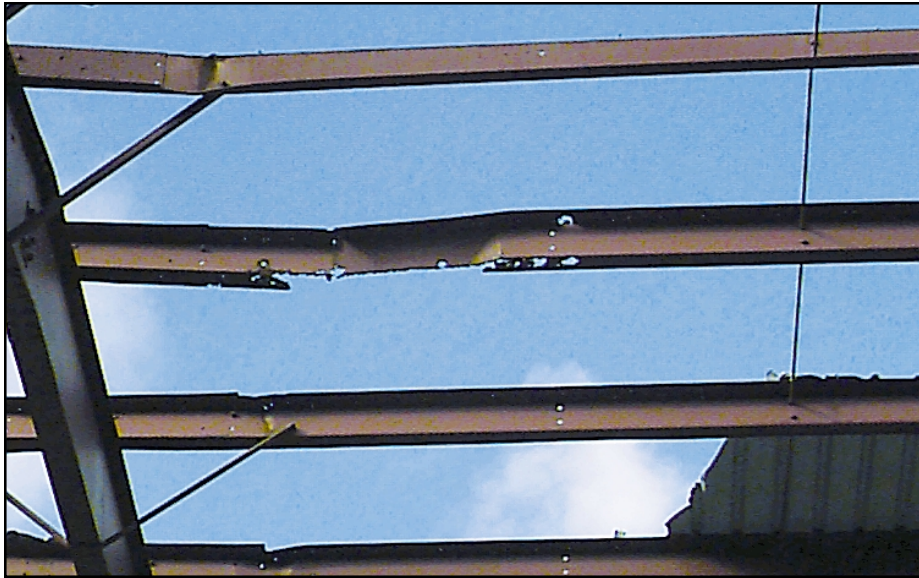
Figure 14-4

Typhoon Paka (1997), Guam. Corrosion observed in the bottom flange of a structural steel roof support member. Photograph by Tom Smith.

- Clean dirt, moss, leaves, vegetative matter, and mildew from wood shakes, and re-coat them with a clear wood preservative.
- Clean corroded surfaces of ferrous metal roofs, and apply an appropriate paint or sealer. Check the attachment of the roof surface to the deck. Screws and nails can work loose and may require tightening. Some roofing systems are attached to the underlayment with clips that can corrode – these clips should be inspected, and any corroded clips replaced. Even structural steel roof support members can become corroded as illustrated in Figure 14-4.

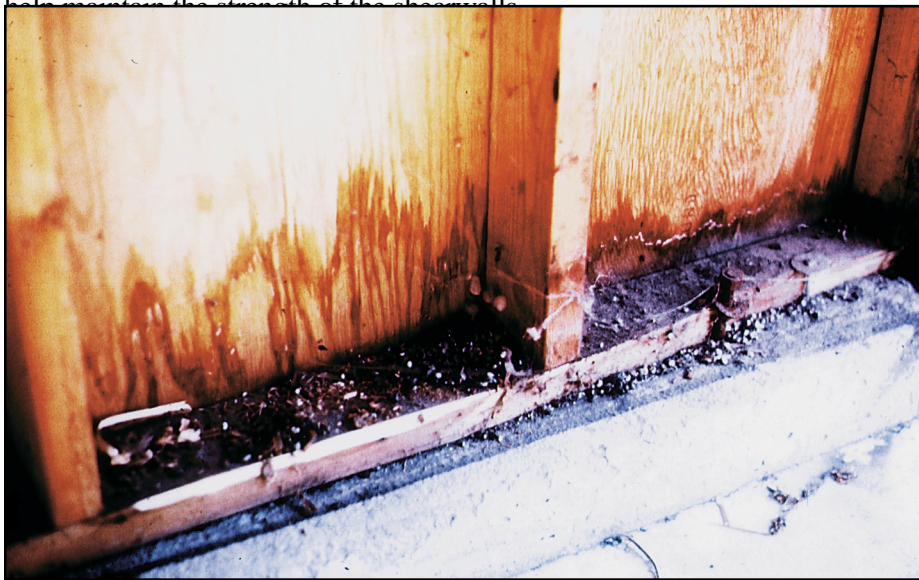
Figure 14-5
Deteriorated wood sill plate.

Shearwall sill plates bearing directly on continuous footings or concrete slabs-on-grade, if used in coastal construction, are particularly susceptible to decay if moist conditions are present. Figure 14-5 shows a deteriorated sill plate. Even if the decay of the preservative-treated sill plate is retarded, the attached untreated plywood can easily decay. As a result, the shear wall will lose strength. Conditions that promote this sill and plywood decay include an outside soil grade above the sill, stucco without a weep screed at the sill plate, and sources of excessive interior water vapor. Correcting these conditions will

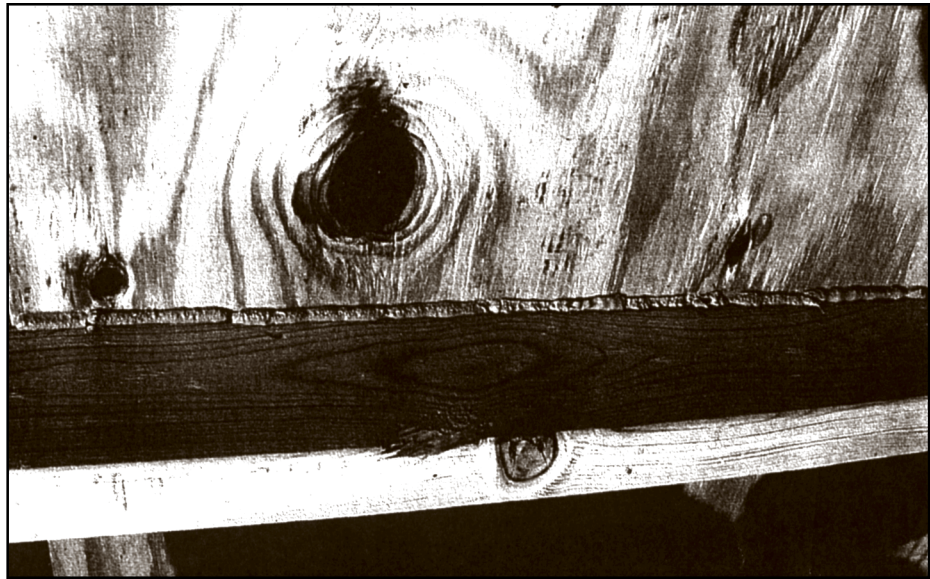
Typical 1/4-inch bead of adhesive between roof sheathing and roof rafter.

- Utility attachment can be improved when the outside equipment is replaced or relocated.
- At any time, in the attic space, straps should be added to rafters across the ridge beam, straps should be added from rafters to top wall plates, and gable wall framing should be braced. In addition, the uplift resistance of the roof sheathing can be increased through the application of adhesive at the roof sheathing-to-roof rafter joint (see Figure 14-6 for an illustration of the adhesive attachment).

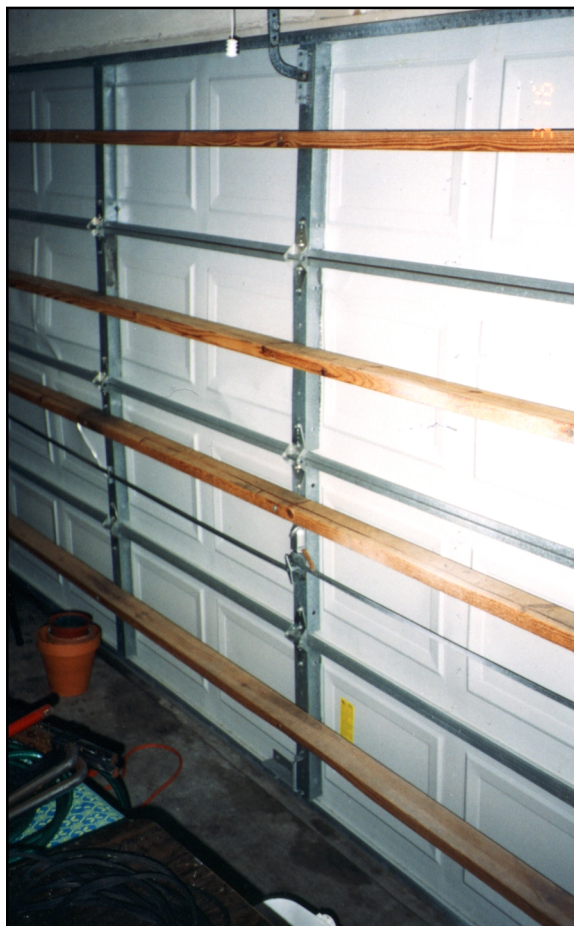
**Figure 14-7**

Garage door on south Florida house reinforced with 2x4 wood girts and metal mullions.

- At any time, garage doors should be reinforced as shown in Figure 14-7, or replaced with new wind- and debris-resistant doors.
- At any time, metal light fixtures should be replaced with fixtures that have either wood or vinyl exteriors.
